PART II. TYPICAL UNACCEPTABLE SOLDER CONNECTIONS

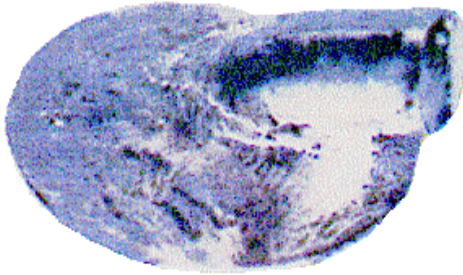
FIGURE 7

PART II. TYPICAL UNACCEPTABLE SOLDER CONNECTIONS	
<p>FIGURE 7</p> <p>Fractured/disturbed solder connection.</p> <p>UNACCEPTABLE</p>	<p>FIGURE 8</p> <p>Poor wetting.</p> <p>UNACCEPTABLE</p>
<p>FIGURE 9</p> <p>Blowhole</p> <p>UNACCEPTABLE</p>	<p>FIGURE 10</p> <p>Rosin Connection</p> <p>UNACCEPTABLE</p>
<p>FIGURE 11</p> <p>Dewetting.</p> <p>UNACCEPTABLE</p>	<p>FIGURE 12</p> <p>Nonwetting.</p> <p>UNACCEPTABLE</p>
